RECLAMATION PRACTICES AND RESEARCH

ON MINERAL EXPLORATION PROPERTIES IN THE YUKON TERRITORY

Published under the authority of the
Honourable Jane Stewart, L., M.P.,
Minister, Indian & Northern Affairs Canada (INAC)
Whitehorse, Yukon, 1998

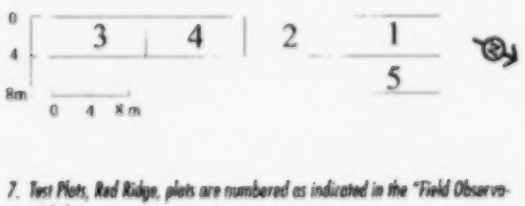
7. Test Plots, Red Ridge, plots are numbered as indicated in the "Field Observations" below.

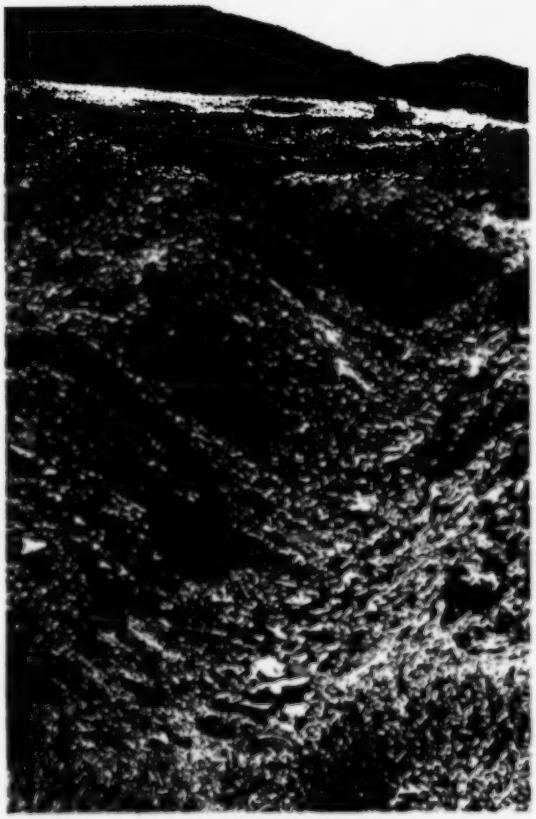
6. View of trench before reclamation, Red Ridge

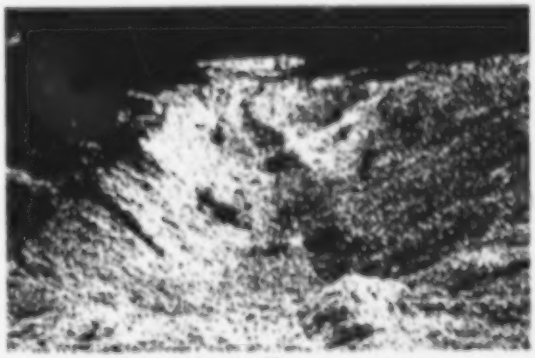
The down slope direction or orientation of the trench is regarded as the worst for instability for such an exploration cut, channelling run-off, and guaranteeing erosion of fine material. A depositional fan has formed at the lower end of this trench over the past six years from the fine material washed out of the upper part of the trench, including the short section in this reclamation test (Figure 13).

13. Nucleus trench showing depositional fan.

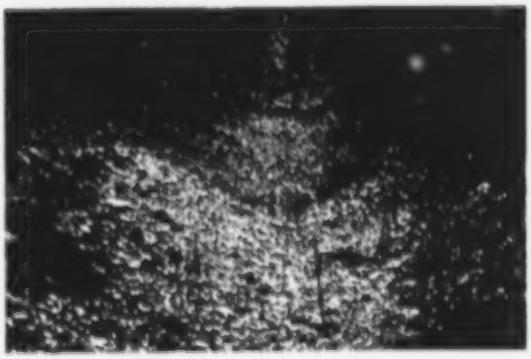
The naturally occurring flora of the adjacent undisturbed area, regarded as the climax stage of plant succession, are listed in Appendix C, a total of 26 species recognized. The trench was cut in 1989. Revegetation in this trench cut by a backhoe is restricted to balsam poplar, black spruce and alder seedlings. Figure 14 shows a spruce seedling 15 cm tall at the Nucleus trench site. Alder grows more rapidly than does spruce in this environment (Figure 15), to greater than one metre in height, presumably in part because of nitrogen fixing bacteria hosted on their root systems.

15. Nucleus trench, alder seedling.

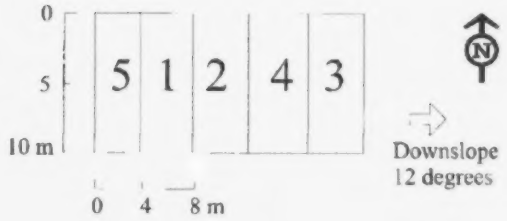
16. Test Plots, Nucleus, plots are numbered as indicated in the "Field Observations" below.

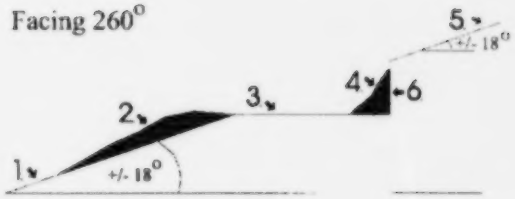
23. Cross Section, Hawk, trench before backfilling

1. Undisturbed downhill slope
2. Excavated material at an angle of repose of 35 degrees
3. Floor of trench, horizontal
4. Material slumped from trench high wall at angle of repose
5. Undisturbed uphill slope, 20 degrees
6. Schist high wall, subvertical

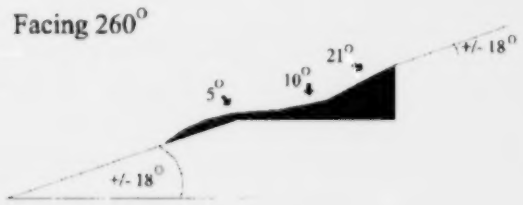
25. Cross Section, Hawk, trench after backfilling

The measured slopes range from 21 degrees at the top to less than 10 degrees on the downhill side. Such slopes are regarded as being stable in this setting of fairly rapid growth. Further, any fine material that does move from the steeper part of the newly formed slope should deposit on the gentler part. The options are limited by the geometry of the original hillside - the average slope of any reclamation profile must average out at about 18 degrees.
